Risk Manager

Beware of Protruding Metal Bars! A Guide to Impalement Safety By Mark Nease

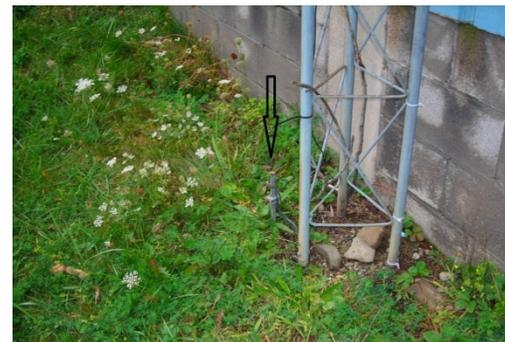
Electrical grounding bars either protruding from the ground or having no physical protection, located near the electrical service entrance of a building.

Drive grounding rods completely into the ground so that they cannot be touched.

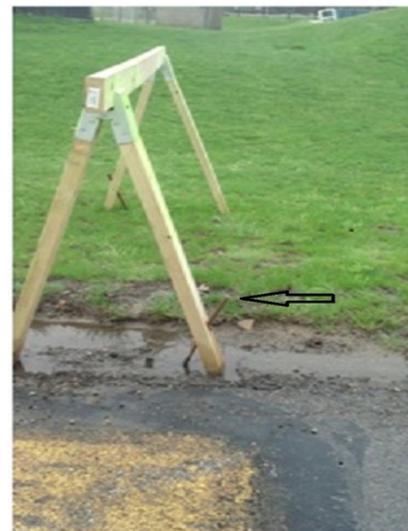
Steel bars, also referred to as rebar, used as spikes to secure parking barriers, signs, landscaping items, etc., to the ground. Rebar also is commonly misused as a property line marker.

Pound or cut exposed metal bars so they are flush with the surface of the item they are securing.

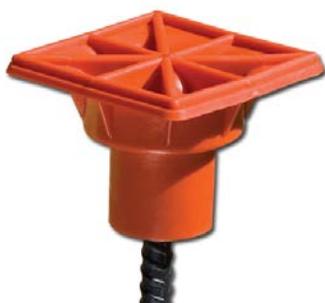
Rebar caps can appear as a one-size-fits-all remedy for protecting against impalement hazards; however, not all rebar caps provide the same level of protection.

Rebar caps that provide impalement protection, instead of those that only offer a visual warning or offer protection against a brush contact.

Install rebar caps that are of the correct size so that when fitted onto the metal bar, the rebar cap will provide the desired protection.

Inspect your rebar caps to ensure they are not missing or damaged.
